BRIDGE DECK EVALUATION PROCEDURE MANUAL

SUBJECT ROUTE 94 BRIDGE OVER LEHEIGH AND HUDSON RAILROAD
BIN 1034840 - SH 154; CHESTER-VAILS GATE
ORANGÉ COUNTY

DATE August 27, 1975
SUBJECT EXAMPLE CASE II REPORT - BIN 1012340
PALISADES INTERSTATE PARKWAY OVER
CLOSTER ROAD
ROCKLAND COUNTY

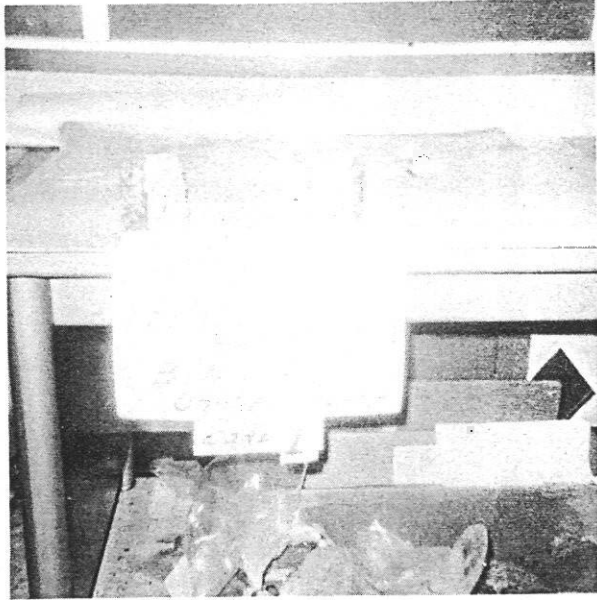
Core #1

CORE #1 - Total Depth 12" - Consists of a 1"+ Asphalt Overlay and 11" of Structural Concrete, most of which is rubble.

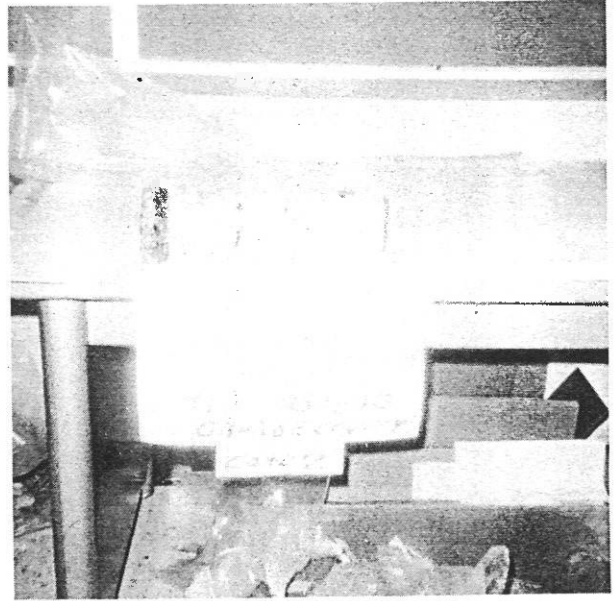
Core #2

CORE #2 - Total Depth 12" - Consists of a 1"+ Asphalt Overlay and 11" of Structural Concrete, broken into three sections.

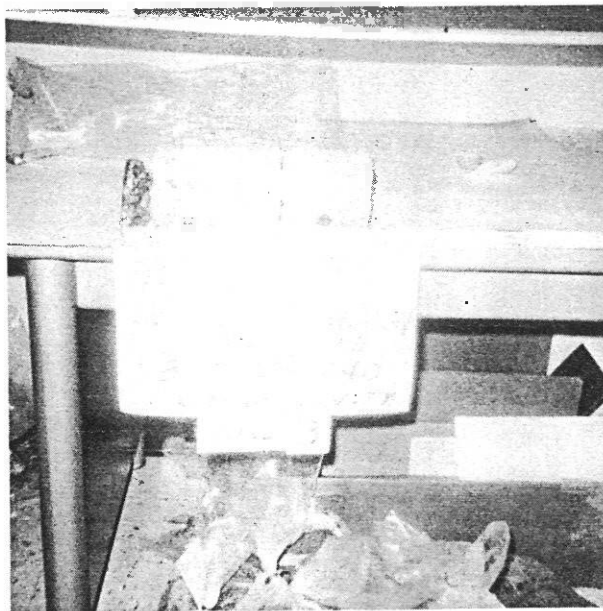
Core #3

CORE #3 - Total Depth 11½" - Consists of a 1" Asphalt Overlay and 10½" of Structural Concrete, broken into two sections.

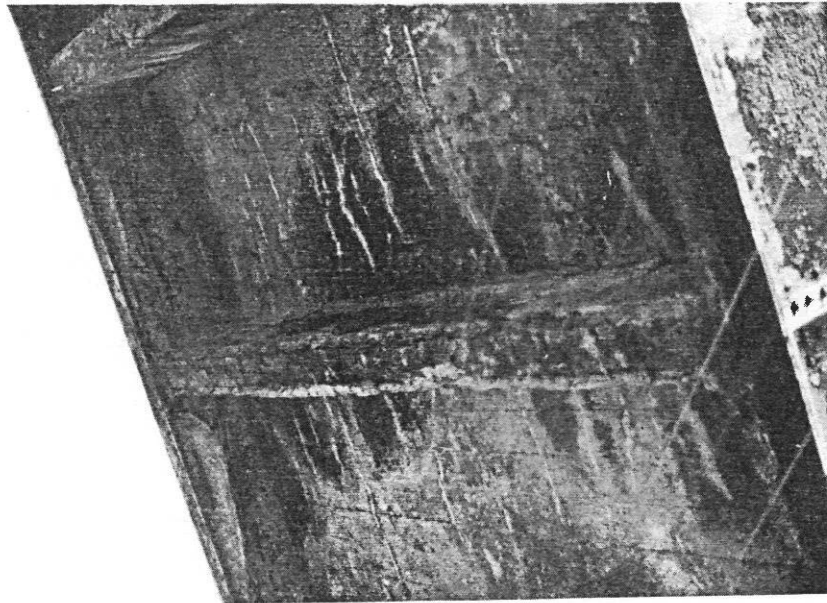
Underside of deck

Three cores were taken from the structure by Regional forces on April 18, 1975. All were progressed thru the deck and were recovered. One of the cores appears quite sound, one has some rubble and one is mostly rubble. Inspection of the underside of the deck showed wide spread leaching and longitudinal cracking. Reinforcing bars are exposed in places and portions of the encasement concrete has fallen down.

Based upon visual interpretation of the core samples and site inspection, we recommend replacement of the entire concrete slab.

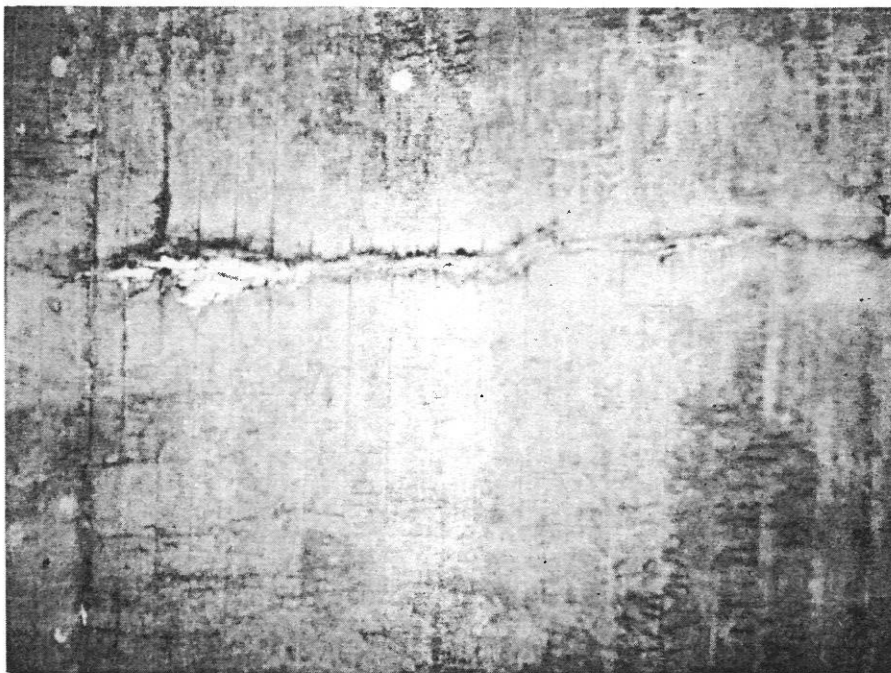
The underside of the deck appears sound except for a longitudinal crack in the Southbound lanes area. Water appears to be passing through this crack as evidenced by leaching appearing on the underside. Heavy leaching is also present on the underside of the deck at the construction joints. The joints are located at the curb lines and in the mall. These leached areas may need repairing.

SB LANE, LONGITUDINAL CRACK UNDER CENTERLINE OF ROADWAY

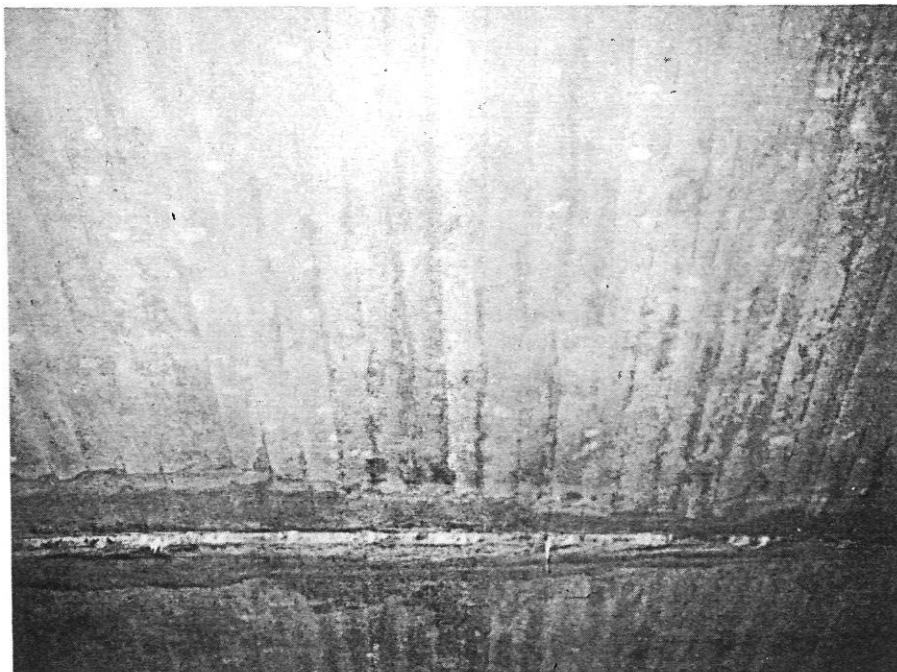
NB LANE, JOINT UNDER INTEGRAL CURB, LEACHED AREA
