# ENGINEERING INSTRUCTION

NEW YORK STATE DEPARTMENT OF TRANSPORTATION

BRIDGE DESIGN DETAILS  
TIE PLATE CONNECTIONS

Code: EI 79-1

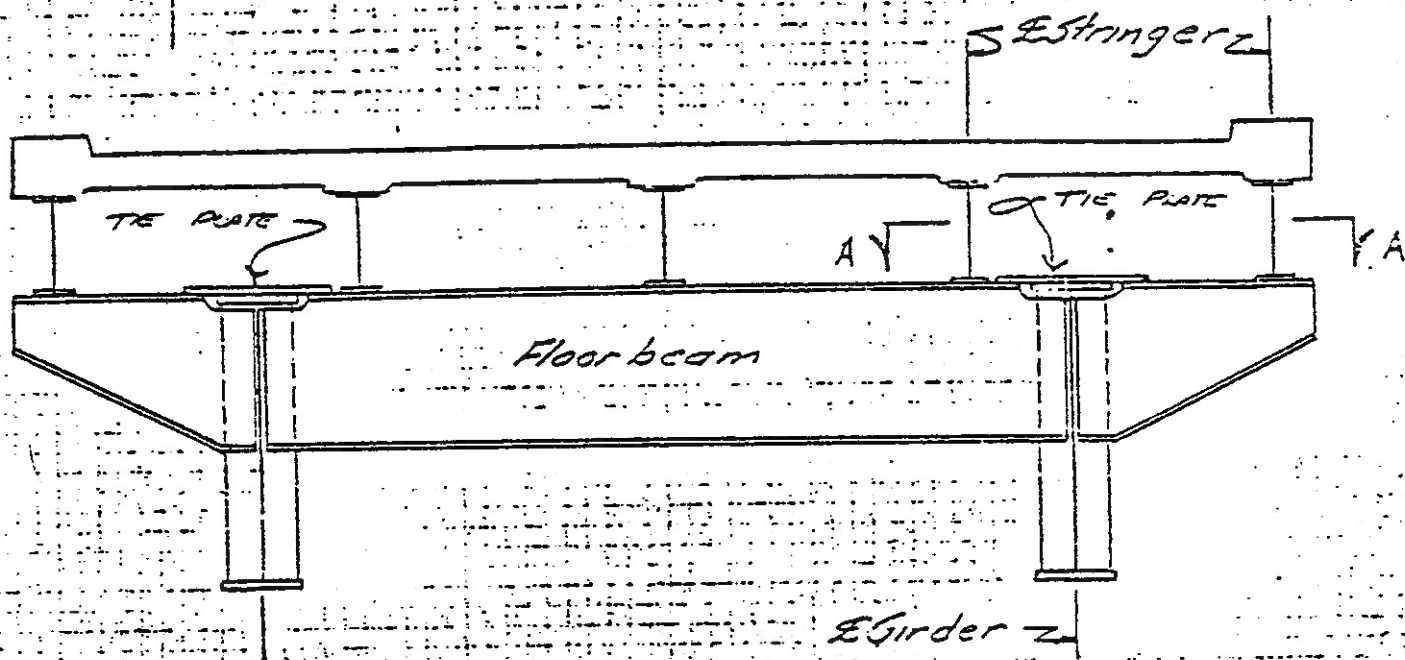
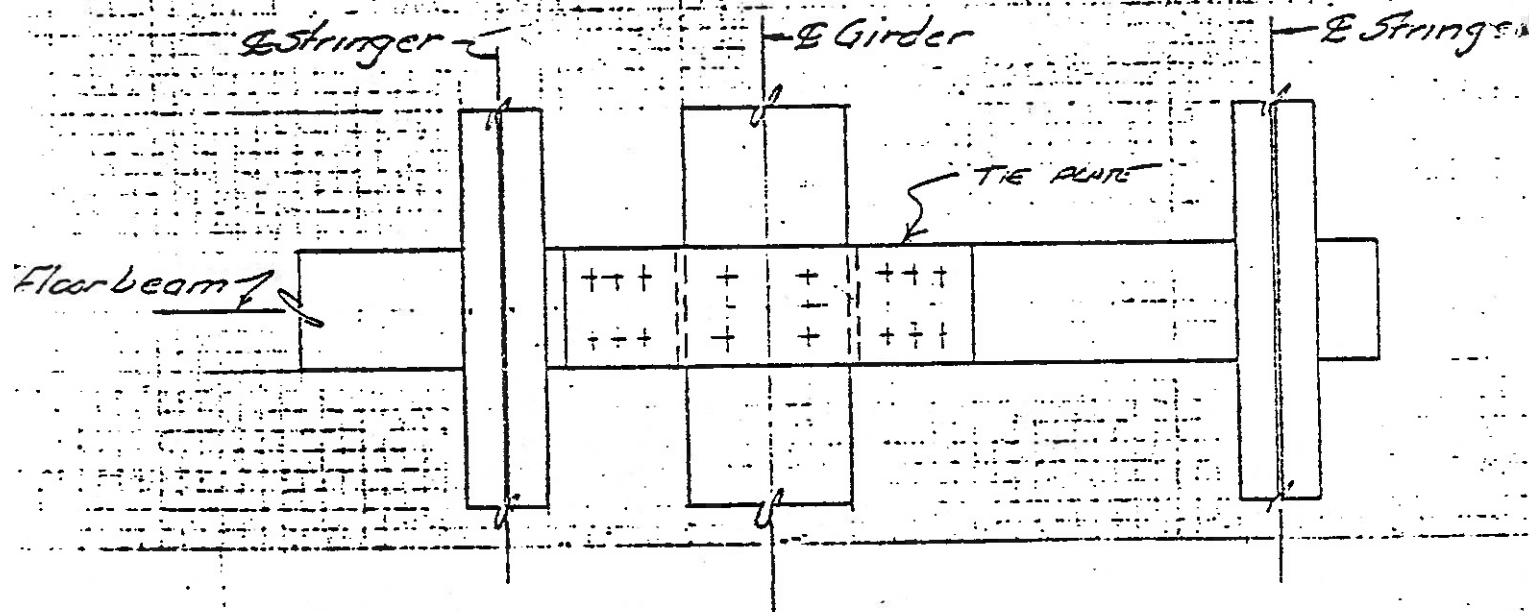
TYPICAL TIE PLATE DETAIL

Attached is a copy of FHWA Technical Advisory T 5040.4 dated August 23, 1978. This advisory warns against employing tie plates for connecting cantilevered floorbeam brackets to main longitudinal girders. This practice can lead to fatigue cracking.

INSPECTION PERSONNEL, when encountering a bridge with cantilever floorbeam brackets, must investigate to determine if tie plates similar to those shown in the sketch are used. If so, the tie plates and the flanges to which they are attached shall be carefully inspected for fatigue cracks. Cracks, if present, should be found adjacent to points of restraint, such as rivets, bolts or welds which connect the tie plate to the flange. Particular attention should be given to tack welds which may be found on riveted or bolted joints.

- b. Due to the cumulative effect of the compression stress in the top flange of the longitudinal girder, a shortening of this flange occurs. This shortening is not shared by the exterior stringers which rest on the top flange of the floor beam bracket and, as a result, a longitudinal displacement occurs in the end of the floor beam bracket relative to the part of the tie plate which is riveted or bolted to the longitudinal girder.

- c. This relative displacement sets up inplane bending stresses of a repetitive nature under live load which are sufficient to fatigue the tie plate to the point of fracture.
- d. This problem is not in evidence in situations where the stringers frame into the floor beam bracket and the flange of the bracket is in contact with the bottom of the concrete slab.

- a. Designs on future projects which utilize this type of detail should avoid bolting the tie plate to the longitudinal girder.
- b. Existing structures which have this detail should be carefully examined for evidence of cracking and the need for repairs. It is recommended that the bolts or rivets which connect the tie plate to the longitudinal girder be removed, and that the holes be protected against corrosion through use of smaller bolts and suitable washers or plates.
